SURVEY REPORT

2003 GEOPHYSICAL SURVEY OF THE JAMES RIVER BEACHFRONT,

TCC LAKE AND J LAKE

FORMER NANSEMOND ORDNANCE DEPOT

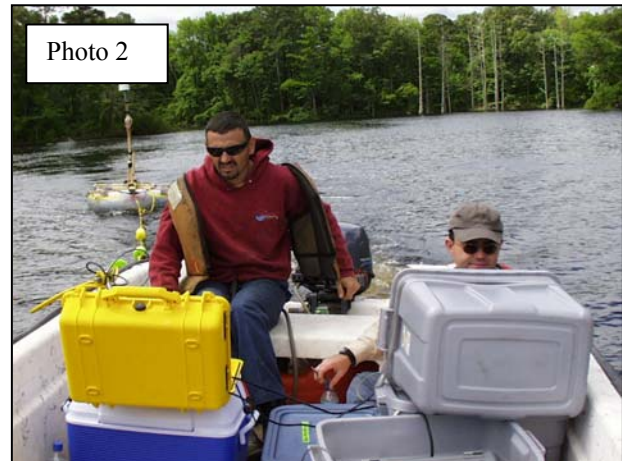
surveyed with mag and bathymetry (Photo 2). As use of the JRB survey vessel was not feasible on the small lake, a smaller 19' outboard-powered skiff was launched from the lake's bank. A new target (Target #11, from the Prove Out) was deployed for the Target Line test. The lake was successfully surveyed during the course of the day with good data coverage obtained. However, the limited maneuverability of the towed raft containing the sensors made positioning on the 25'-spaced survey lines proposed in the Work Plan difficult to achieve. Despite heavy tree cover, DGPS signal integrity was maintained. In the real-time mag data stream, several pronounced responses were observed when surveying the northern end of the lake (the westernmost of which appeared to correspond to a water level gauge). A number of focused survey lines were run in this area to clearly define the location of the target(s).

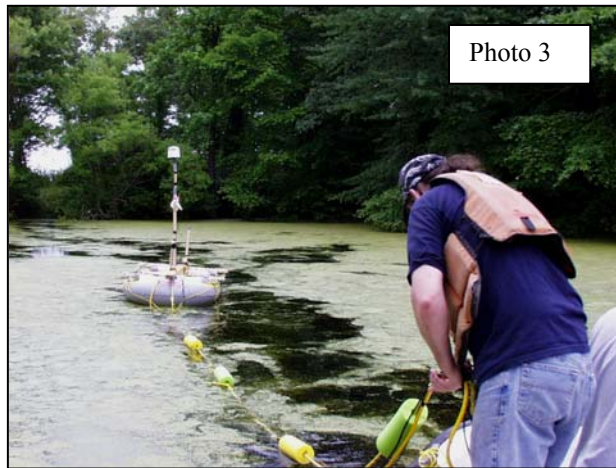
On June 3rd, a second survey team was employed so that surveying could continue at both the JRB and lakes simultaneously. One team conducted the mag and bathymetry survey of J-Lake (Photo 3). The mag performed well, but abundant aquatic vegetation frequently fouled the bathymetry transducer. Despite frequent cleanings, a number of no-data points were observed in the dataset. However, coverage of the remaining data appeared sufficient.
